CITY OF LAMAR, COLORADO  
CULTURAL RESOURCE SURVEY

SHF PROJECT # 2010-M1-013

## Architectural & Historical Survey Report

History Colorado - State Historical Fund  
Project Number 2010-M1-013  
Project Deliverable #8

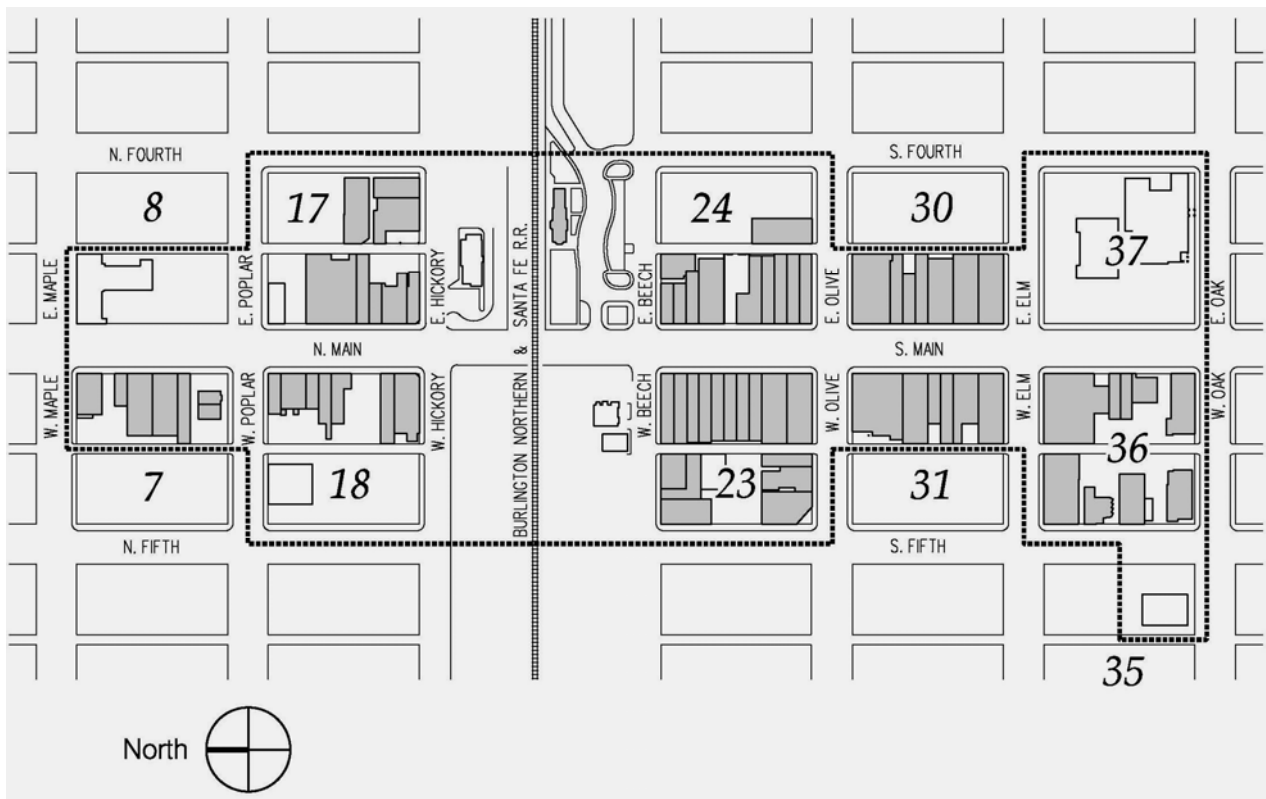
**Figure 3.**

The project area included in the City of Lamar Cultural Resource Survey is shown on this map. The project area is located in the Sixth Principal Meridian, Township 22S, Range 46W, Section 31 (USGS East Lamar, Colorado Quadrangle).

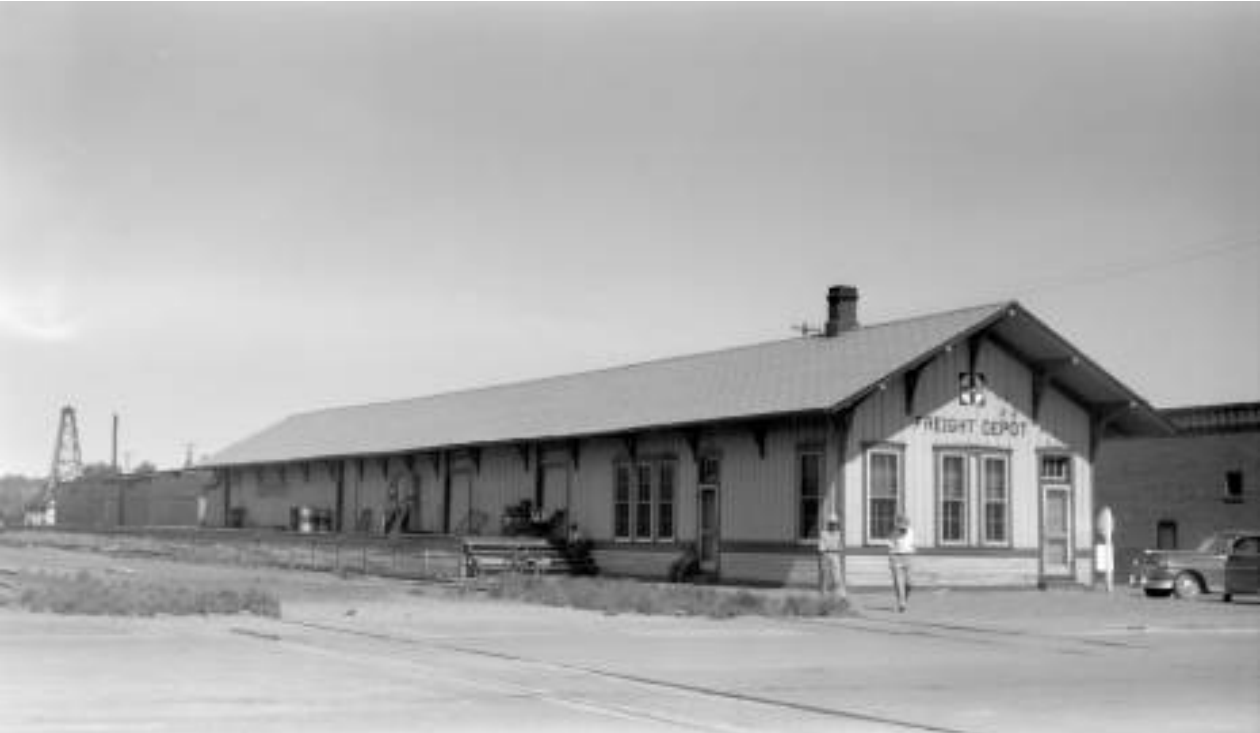
**Figure 7.**

The depot that had been moved to Lamar from the Town of Blackwell burned to the ground in March of 1888. It was temporarily replaced by four box cars, which town promoters thought presented a poor image to potential settlers of the fledgling new town. This depot was constructed on June 23, 1888 and has subsequently been replaced by the one currently located at 109 East Beech Street (5PW.324).

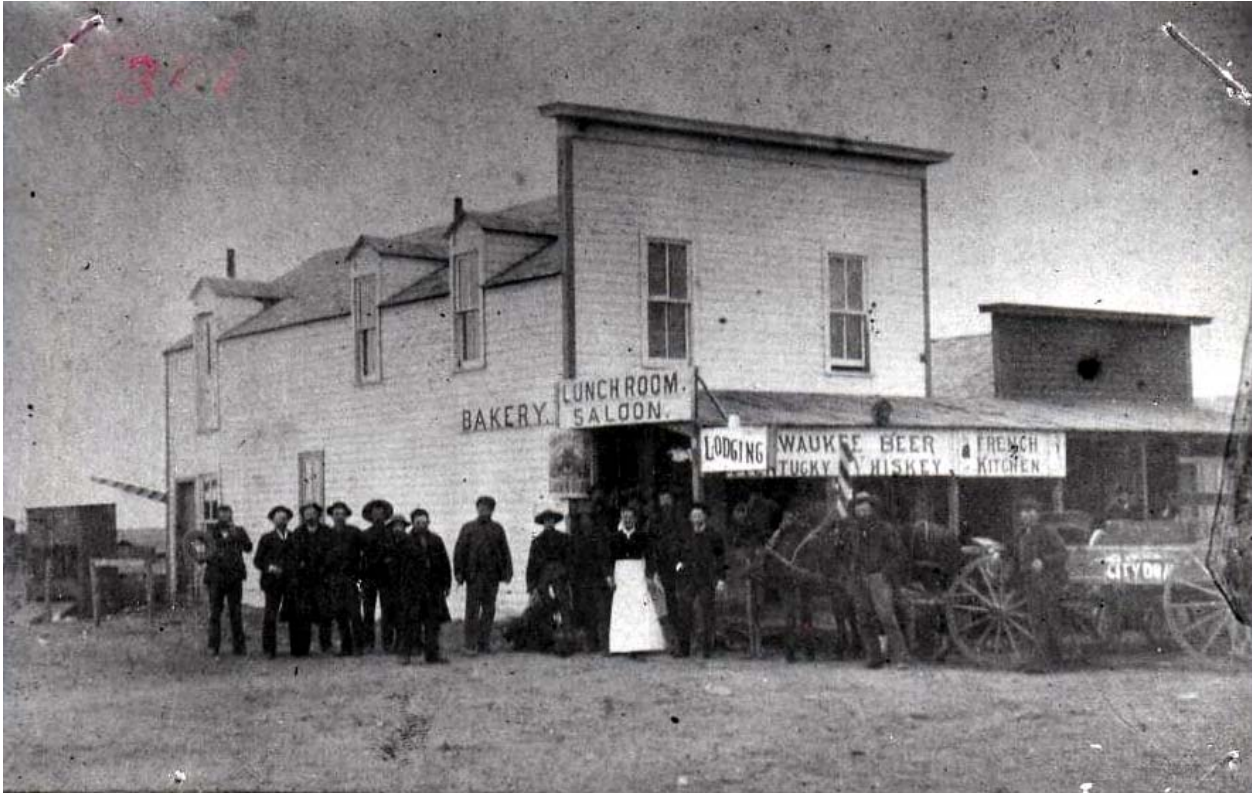
**Figure 9.**

The John Hess Saloon was an early structure in Lamar. It was consumed by fire in 1891. Other buildings on Block 17, located on the east side of North Main Street, burned during the conflagration.

Water facilities became available in Lamar by 1906 and the population had grown to 3,000 residents. The “fire limits” of the town were now defined, with Maple and Oak serving as the north and south boundaries; 4<sup>th</sup> and 5<sup>th</sup> Avenues, located one block to the east and west of Main Street, were the boundaries between Poplar to the north and Olive to the south. North of Poplar and south of Olive, the fire limit boundary was offset to the alleys behind the commercial buildings along Main Street. (Refer to Figure 2 on page 4.) Thus, the core business district was protected with fire hydrants (or plugs) by 1906, an important feature after the devastating fires of the 1880s and 1890s. (Refer to Figures 8 and 9.)

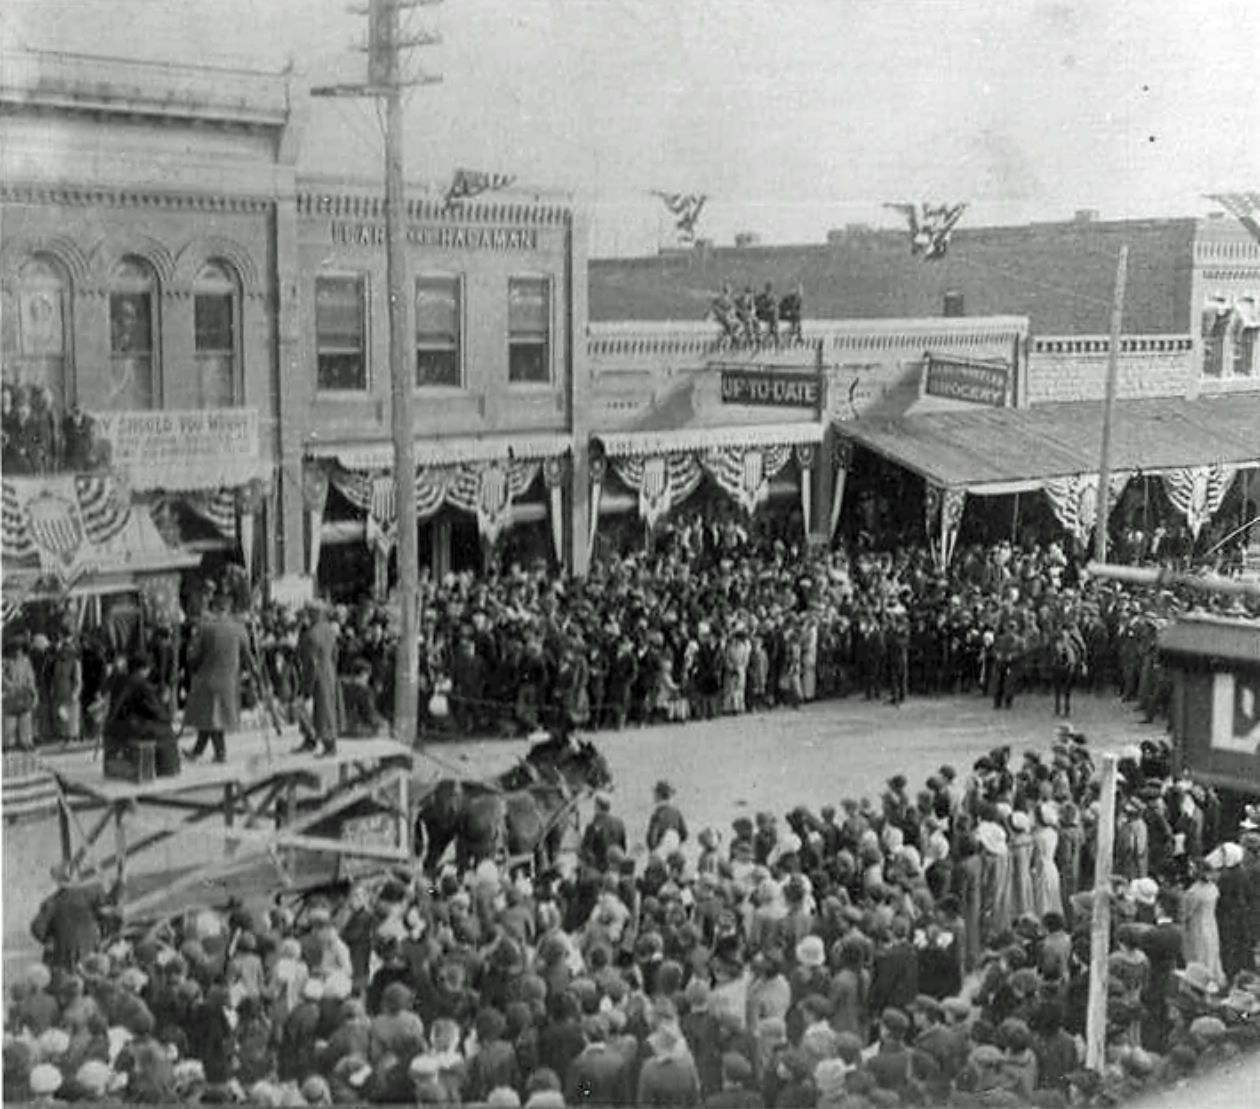
**Figure 10.**  
A celebration of the opening of the Lamar Plant of the Helvetia Milk Condensing Company occurred on January 5, 1914. The east side of the 100 block of South Main Street can be seen here. Buildings, beginning from the left side of the photograph, include the Opera House Block (now demolished), 115 S. Main - 5PW.339, 119 S. Main - 5PW.341 (Up-To-Date Drug Company), 121 S. Main - 5PW.343 (Marx & Wheeler Grocery), 123 S. Main - 5PW.345 (A. Everett Meats), and 125 S. Main - 5PW.346 (E. E. Butler Groceries, Dry Goods & Shoes).

Other businesses located in Lamar include the Helvetia Milk Condensing Company; it built a plant in 1914 for the canning of milk, known as Pet Milk. (Refer to Figure 10.) The establishment of this business resulted in an increase in dairy farming in the area until 1932 when improved technology allowed fresh milk to become available to consumers and the Lamar plant closed.

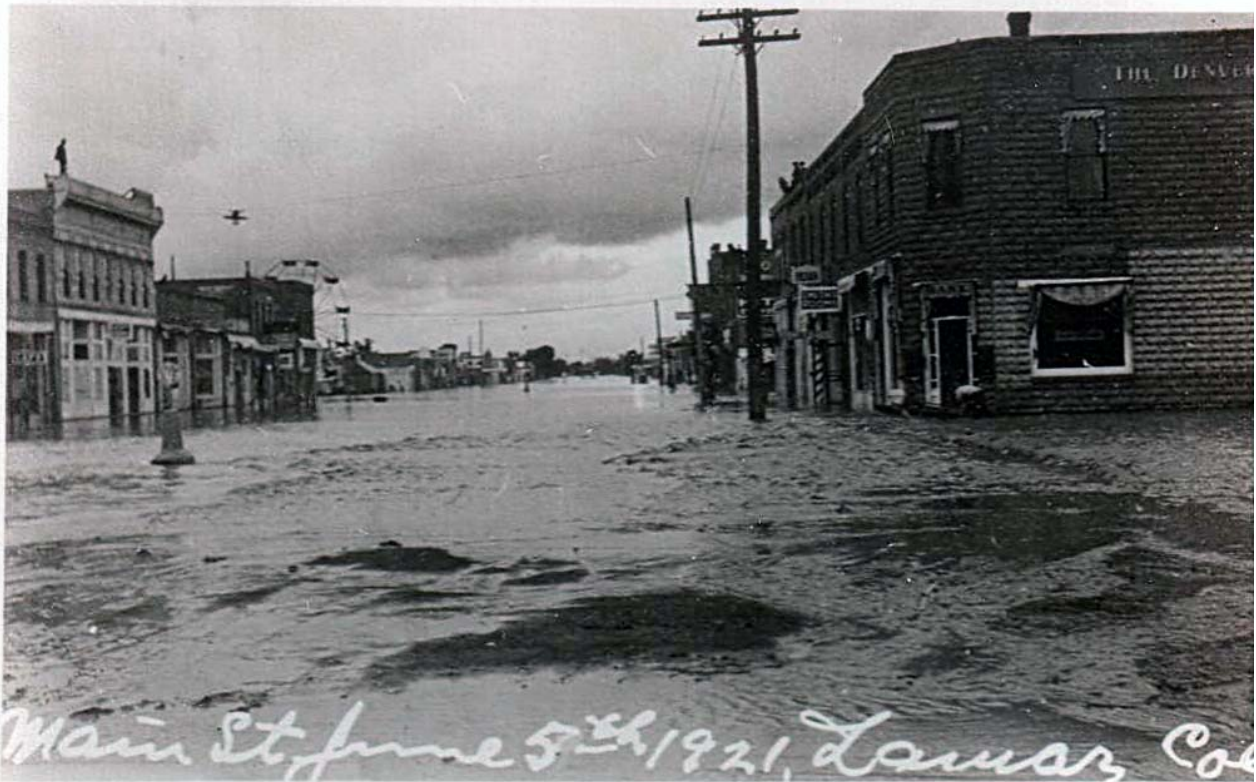
**Figure 12.**  
The flood waters from the Arkansas River filled Lamar’s downtown streets, seen in this view looking north toward the 100 block of North Main Street. The ornamental concrete block building at 100 North Main Street – 5PW.318, on the right side of the photograph at the corner location, 102-104 North Main – 5PW.316, and 106 North Main – 5PW.314 remain extant.

to area irrigation ditches, roads and bridges. The first floor of downtown businesses flooded. (Refer to Figure 12.) Total damage in Lamar was estimated at \$640,000.

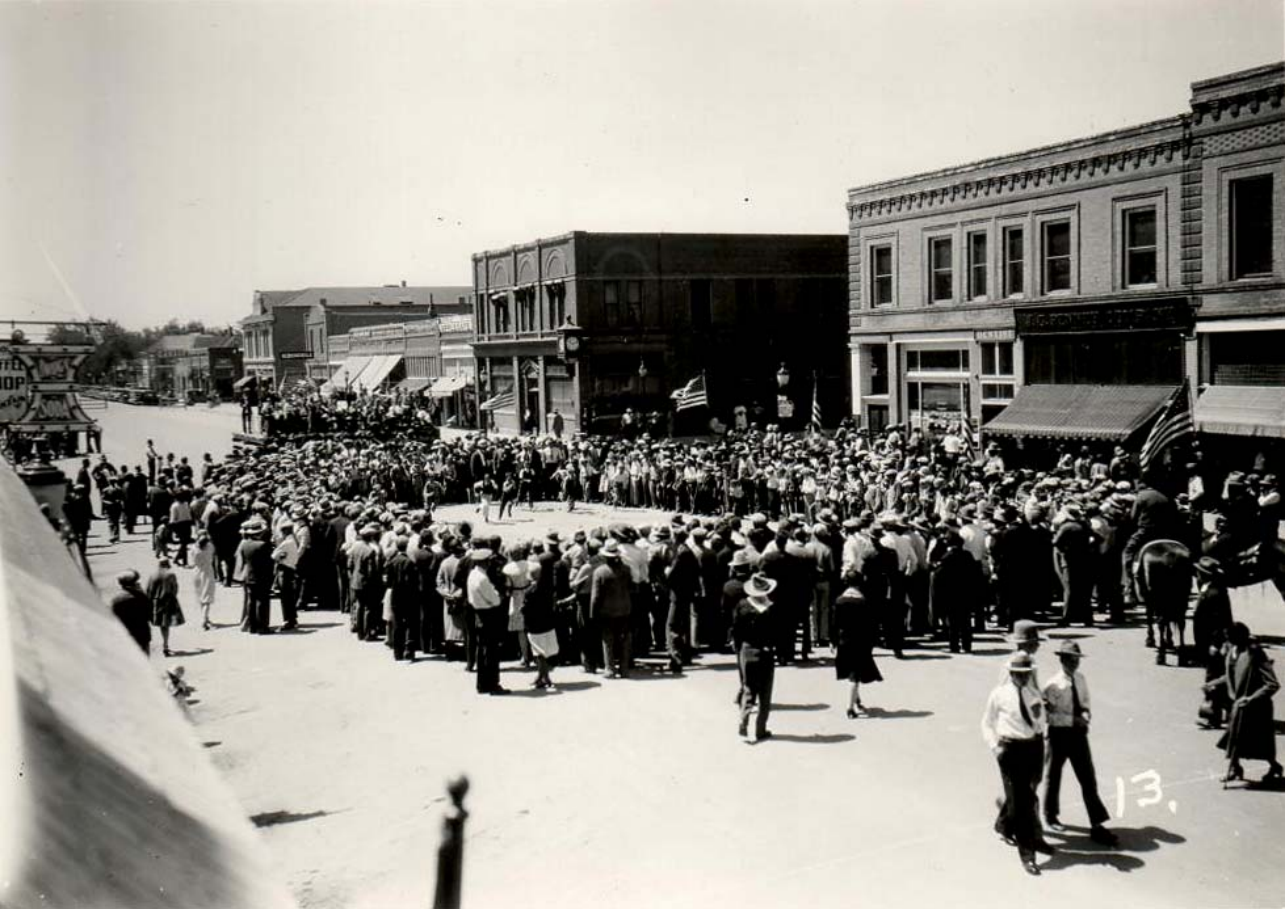
**Figure 13.**

The 45<sup>th</sup> anniversary of the founding of Lamar occurred in 1931 during the Great Depression. This view looking south on Main Street reveals the original appearance of some of the buildings on the 100 and 200 blocks of South Main Street. The building on the right side of the image is 120-122 South Main Street – 5PW.342; a portion of 116 South Main Street – 5PW.340 is also visible. The building at 200 South Main Street – 5PW.351, which was the home of Lamar National Bank in 1931, was demolished circa 1964 for the construction of First National Bank.

The “Black Tuesday” stock market crash of 1929 marked the beginning of the Great Depression. The gross national product was reduced in half and unemployment reached 25%. Wheat that had been valued at \$1.42 in 1890 now sold for twenty-five cents. Although the Depression affected the thriving economy of Lamar, the city celebrated the 45<sup>th</sup> anniversary of its founding in 1931 to much fanfare. (Refer to Figure 13.)

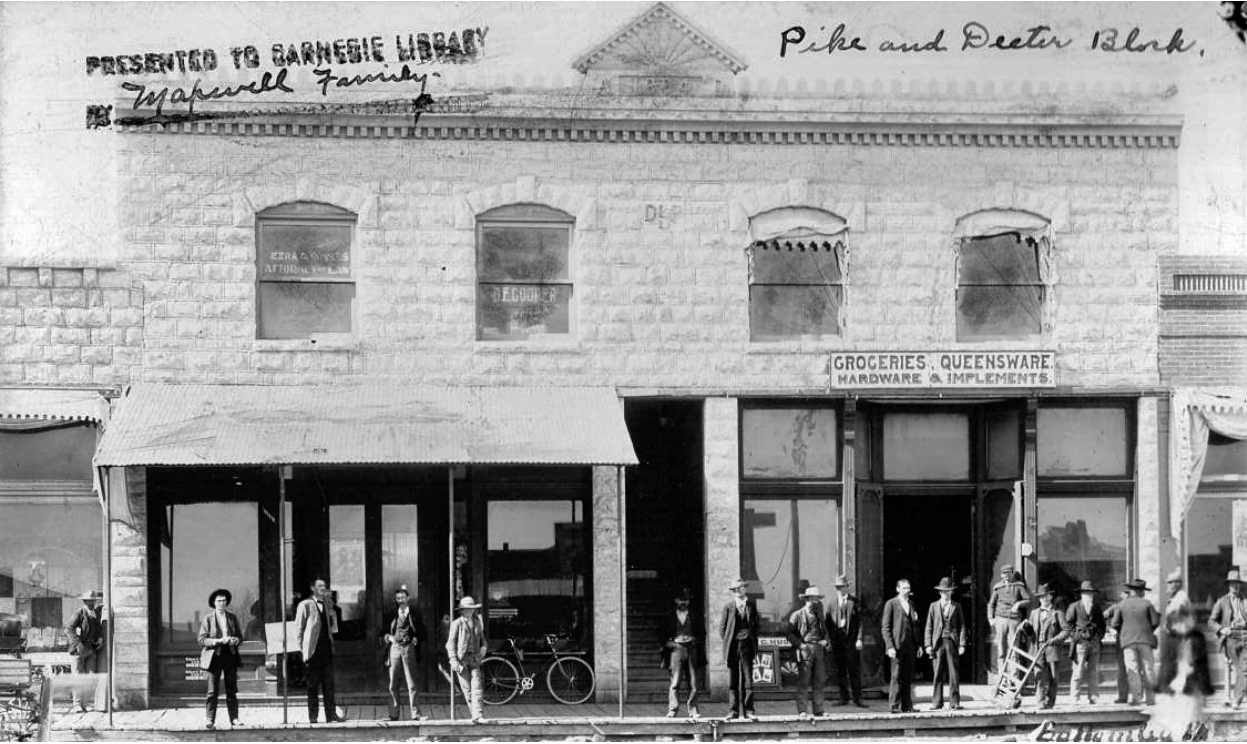
**Figure 17.**  
**THEN:** This building at 112 – 114 South Main Street (5PW.337 – 5PW.338) was built circa 1894. Known as the Pike and Deeter Block, it is one of the oldest buildings in the survey area. Although it was designed as a single building, each half is separately owned. Refer to Figure 19 for this building’s current appearance.

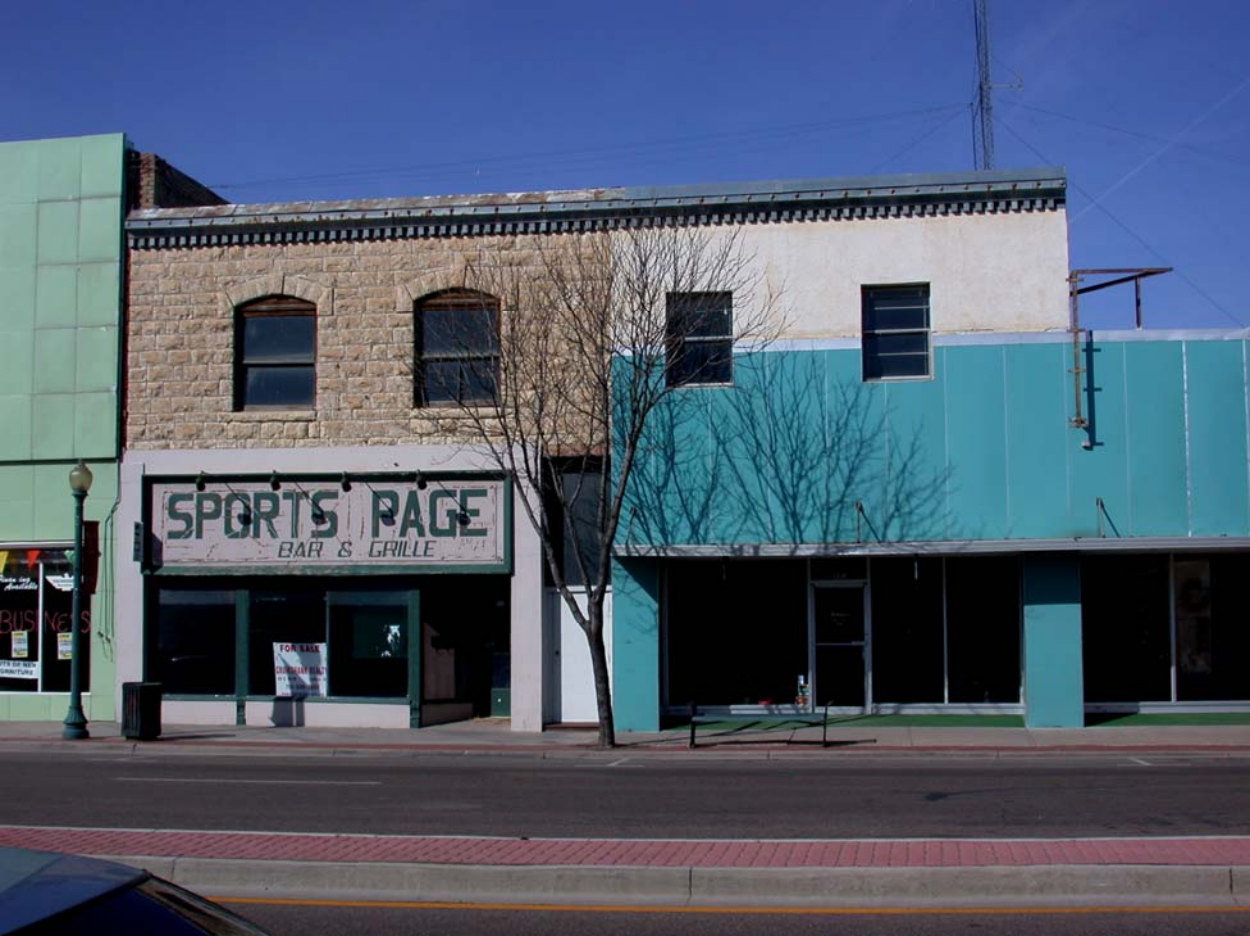
**Figure 18.**

**NOW:** The building at 112-114 South Main Street (5PW.337 – 5PW.338), known as the Pike and Deeter Block. The addition of metal siding and stucco to the exterior walls, the replacement of the first floor storefront with an anodized aluminum framing system, and the reduction in size of the second floor window openings at 112 South Main Street (5PW.337) was possible because each half of the building is separately owned.

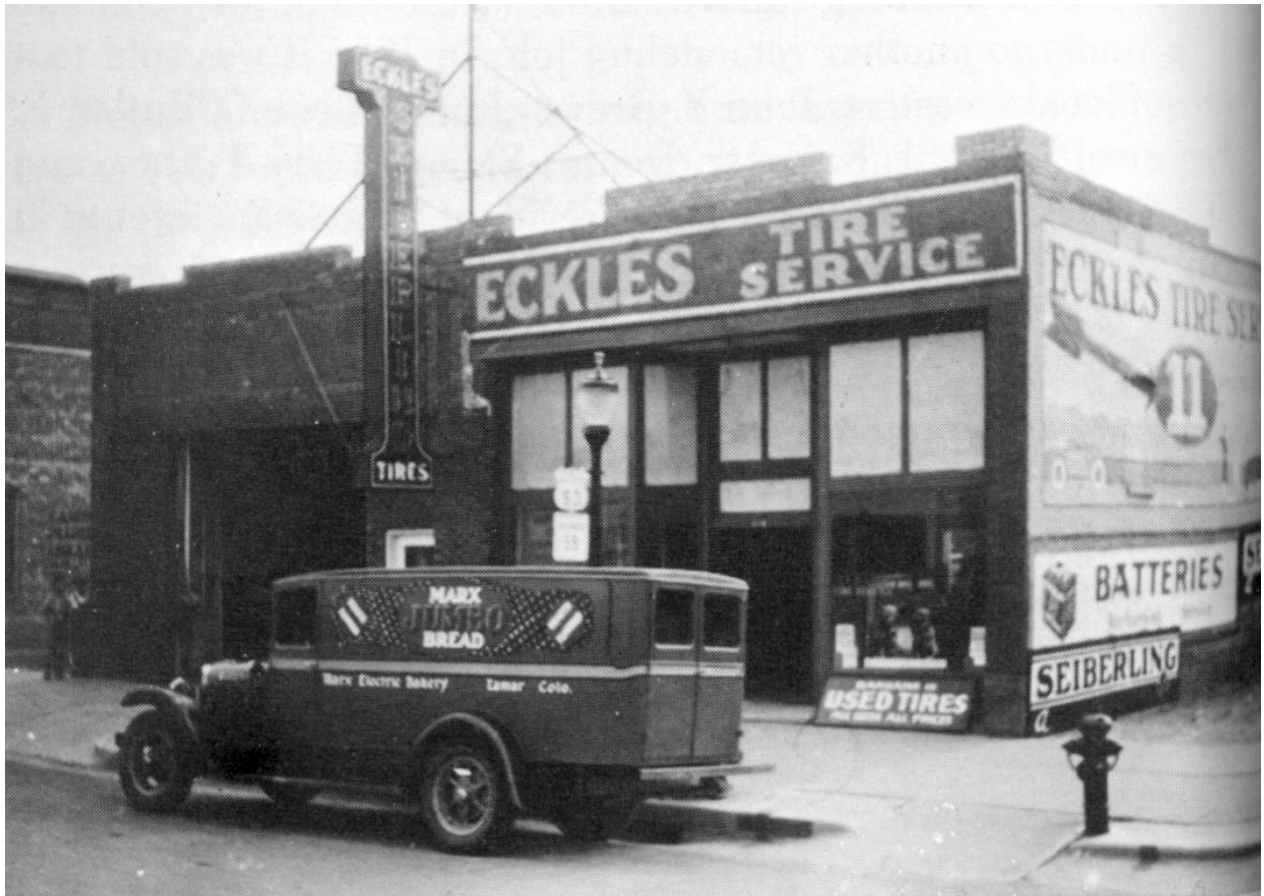
**Figure 19.**

**THEN:** Eckles Tire Service was located at 223 North Main Street (5PW.301), built circa 1931. Appliances were later sold here. The building remained in the Eckles family through circa 1977. Refer to Figure 20 for this building’s current appearance.

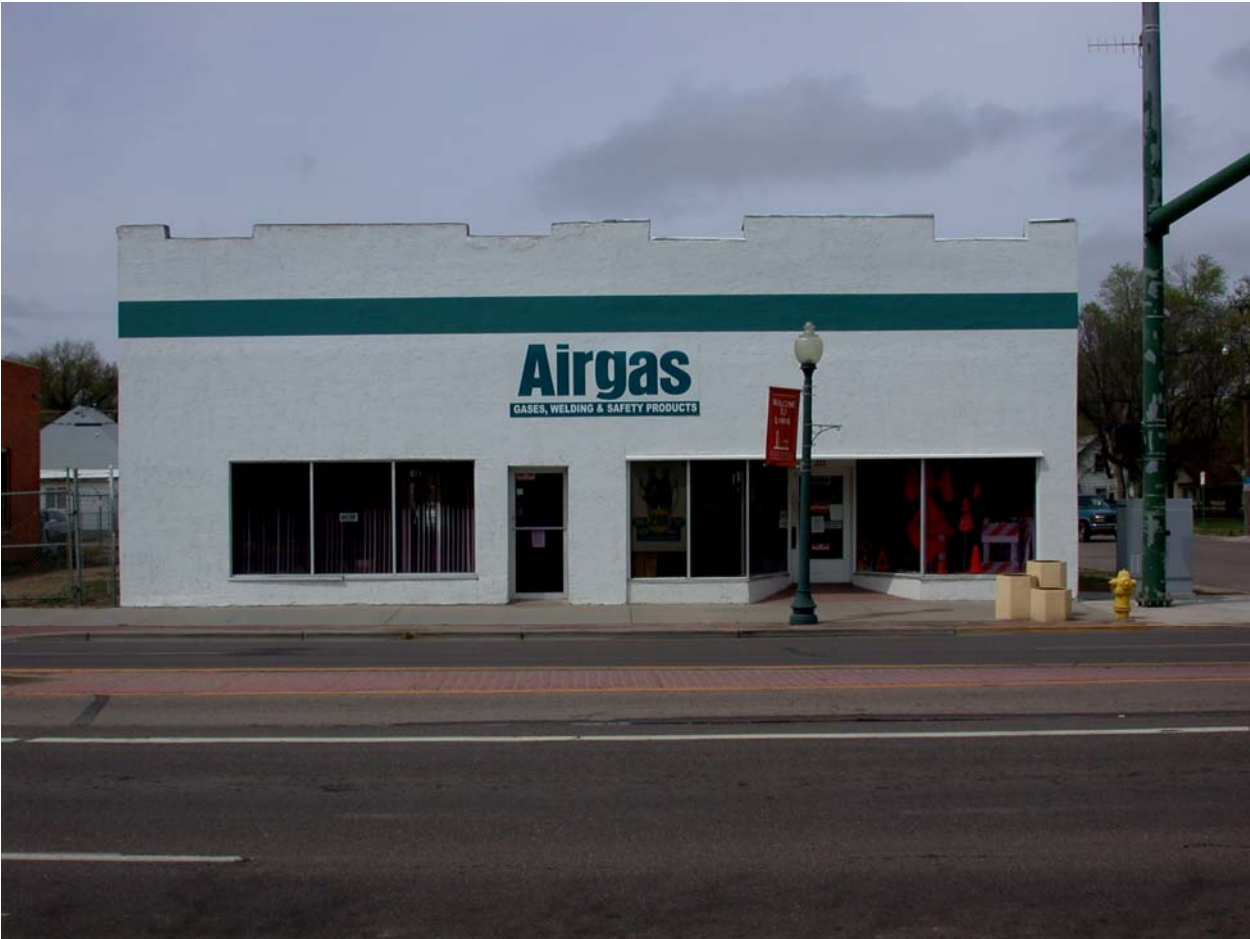
**Figure 20.**

**NOW:** The original stepped parapet remains at 223 North Main Street (5PW.301) but the building’s other original architectural features from its circa 1931 construction have been modified as seen in Figure 19.

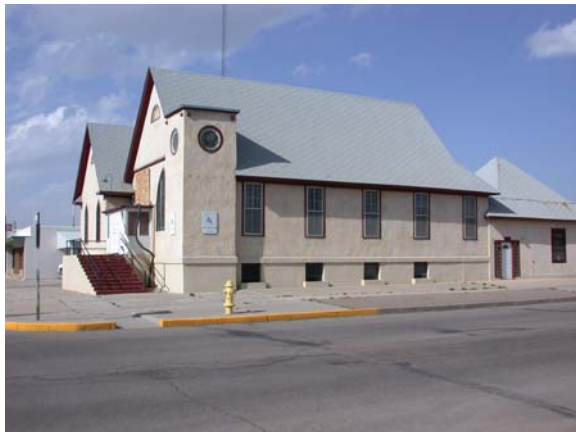
**19. 108 West Oak Street        5PW.367**  
**First Baptist Church            1908 - 1948**

The Late Victorian style (1880 – 1910) is represented in the First Baptist Church at 108 West Oak Street – 5PW.367 with its multiple gabled roofs, corner bell tower, pointed (Gothic) arched window openings containing stained glass, and decorative wood shingles on the gable ends of the former parsonage, which now functions as an educational wing.

incorporating features of the Late Victorian style of architecture as adapted to a local church with a period of significance of 1908 to 1948, which includes the time when the building was altered. The building's character defining features include its multiple gabled roofs; the corner bell tower; the pointed (Gothic) arched window openings containing stained glass, which were added to the church circa 1924; and the decorative wood shingles on the gable ends of the former parsonage, now an educational wing.

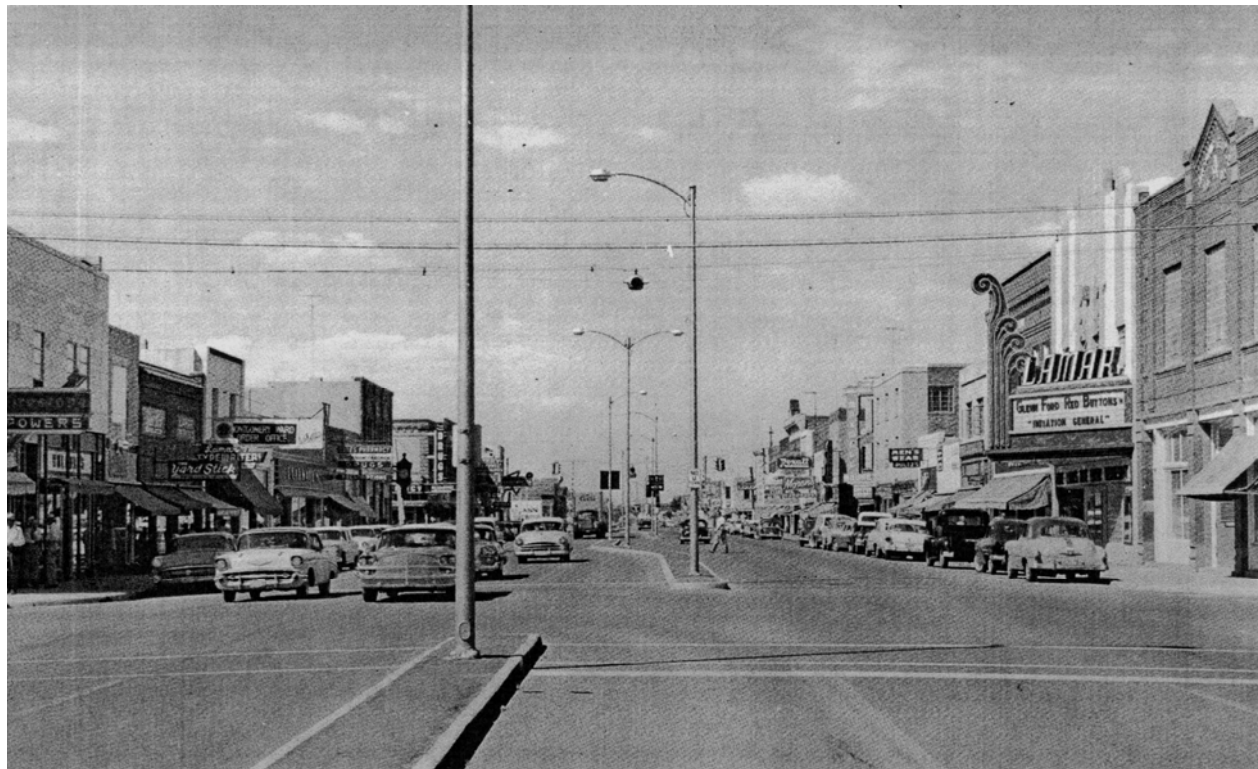
**Figure 21.**

The 200 block of South Main Street was featured on the cover of the 59<sup>th</sup> Annual Convention of the Colorado State Council in April of 1960. The storefronts remain intact on both sides of the street, indicating that many of the building alterations seen today occurred sometime after 1960.
